**MANDATORY BULLETIN No. EV 97 – 002a**  
**P-220 UL – 002a**

1. **REFER TO :** Ultralight airplanes EV-97 EUROSTAR S/N 9700X2, 9700X3, 980101-980106, 980202-980206, 980301-980304, 980306 and P 220 ULR S/N 96007486, 960003, 960005, 970006, 970009, 970102, 970104, 970105, 970107-970113, 980114-980120

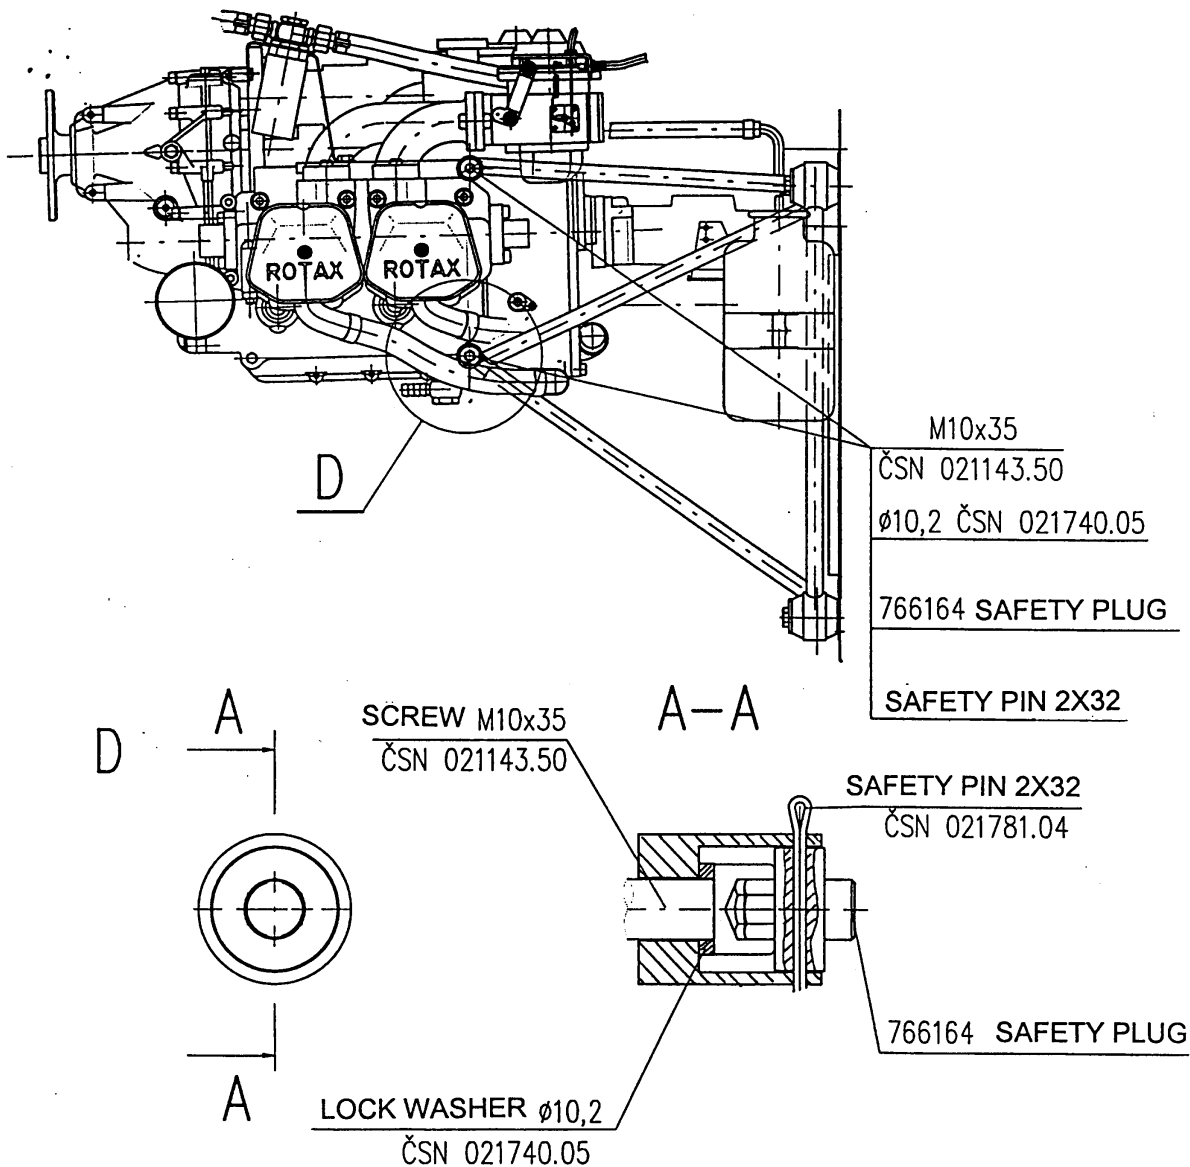
2. **REASON :** A loosening and consequent deformation of the lower left engine-engine bed attachment screw has been detected during operation of the EV-97 EUROSTAR aircraft.

The upper and lower fiberglass engine cowling should be removed to make accessible the engine-engine bed attachment screws.

Remove the safety pin, loose and remove the lower left engine suspension screw (supporting engine is recommended to unload the screw).

Visually check the screw for condition, deformation, and damage. When you found defects replace the screw by a new one supplied by the manufacturer on your request. The lock washers 10.2 ČSN 02174005 must be under the screw head. If flat washers are installed under the engine suspension screws, replace them by the lock ones supplied by the manufacturer on your request. Tighten the screw(s) using a torque wrench (torque moment 44 N.m) after replacement, secure with safety pins.

If there were not installed safety plugs on your aircraft, we recommend you to install them (the plugs are supplied on your request).
